SYGMA NETWORK, INC.

SOUTH PARKING LOT IMPROVEMENTS

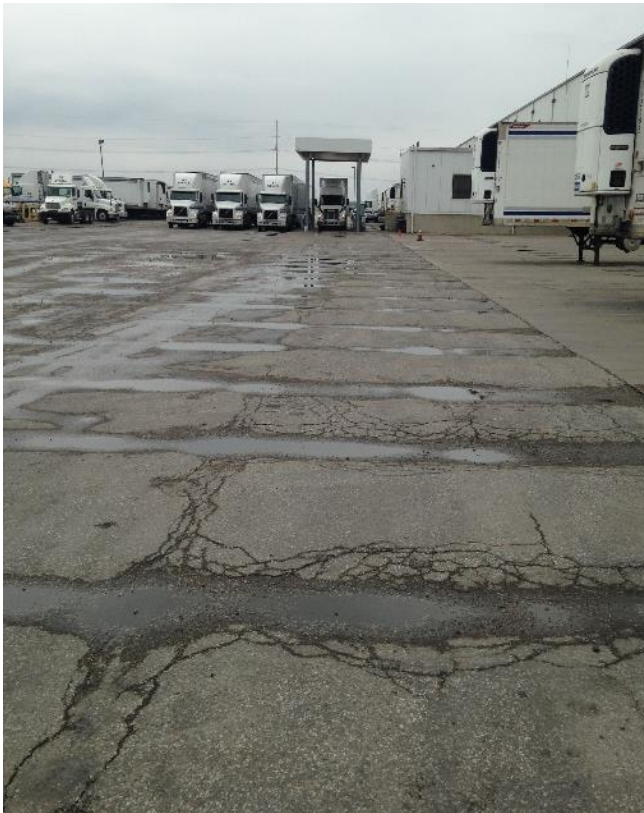
Before

1. Minimal surface grades and poor stormwater conveyance.
2. Significant pavement deterioration throughout the parking lot (pot holes, rutting, cracking).
3. Design required new construction to fit in the same footprint of existing parking lot.
4. Detailed construction sequencing and staging plan to ensure facility remained fully operational.

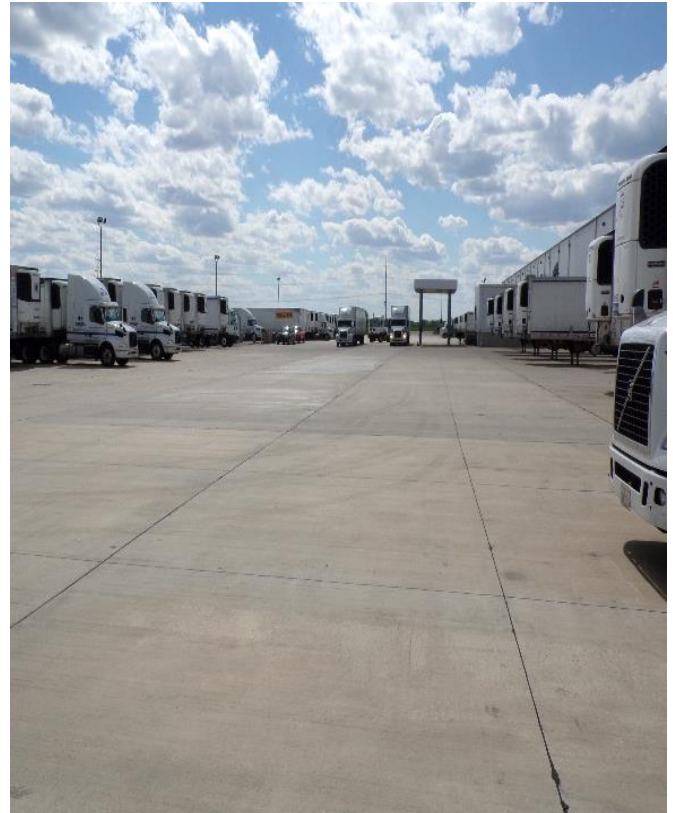
After

1. Designed heavy-duty pavement with a life expectancy of 20 years to handle estimated traffic loads.
2. Modified existing pavement slopes to improve overall site drainage to reduce ponding and icing in the winter.
3. Improved stormwater conveyance by with 900 feet of combination underdrain and storm sewer (12"-30")
4. Improved rideability by eliminating pot holes, rutting, and cracking.
5. Developed detailed traffic control plan and construction sequence minimize disruption to operations at the facility.
